Mulkey-Monache Grazing Allotments, Golden Trout Wilderness
Head Cut and Photo Point Monitoring, 2003 and 2011 (DRAFT)

By: Casey Shannon, Hydrologic Technician
Inyo National Forest, Supervisor's Office
January, 2012

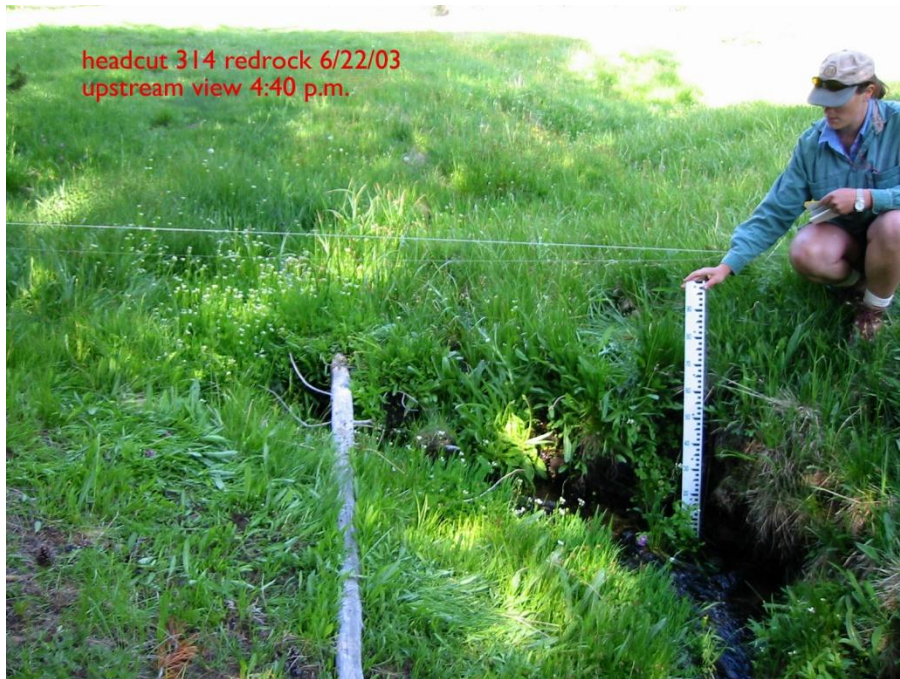
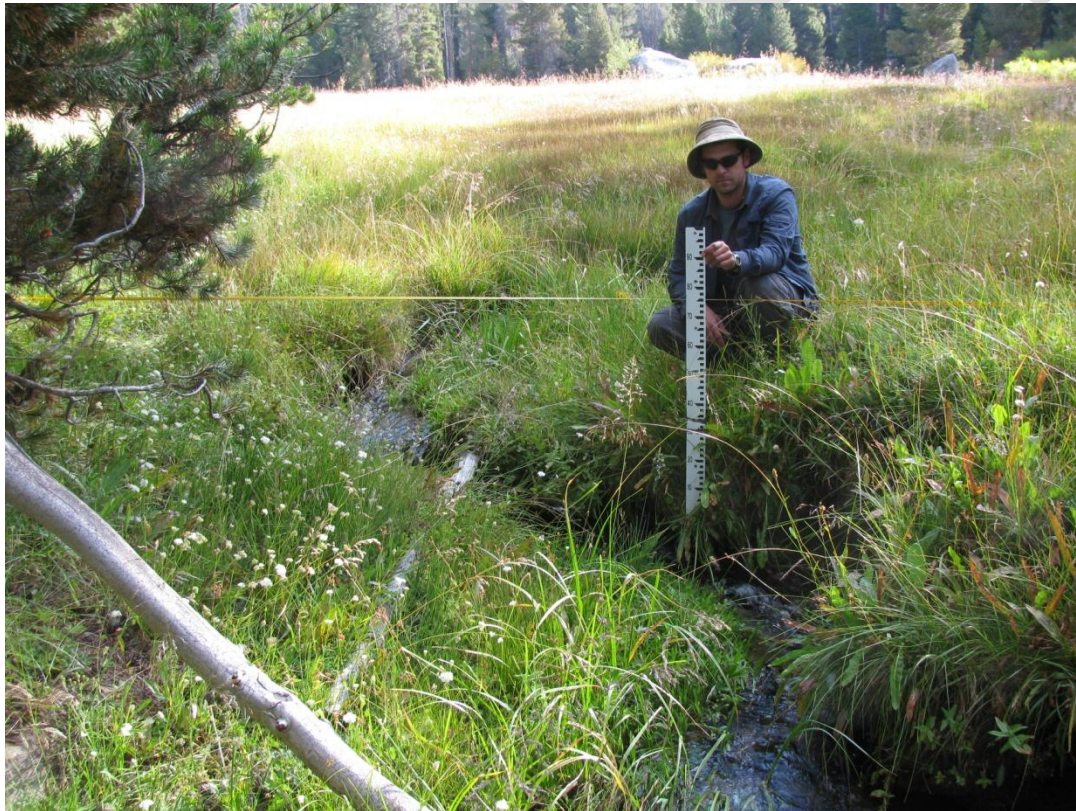
Above photo: Head Cut 314 (HC-314, Redrock Meadow, June 2003. It is a small headcut in the channel with a steep face. **Below photo:** HC-314 Redrock Meadow with photo re-taken September, 2011. Headcut has not migrated, and no longer exists. Channel has adjusted to natural gradient. No need for future stabilization treatment. Stream banks are very stable at this site.

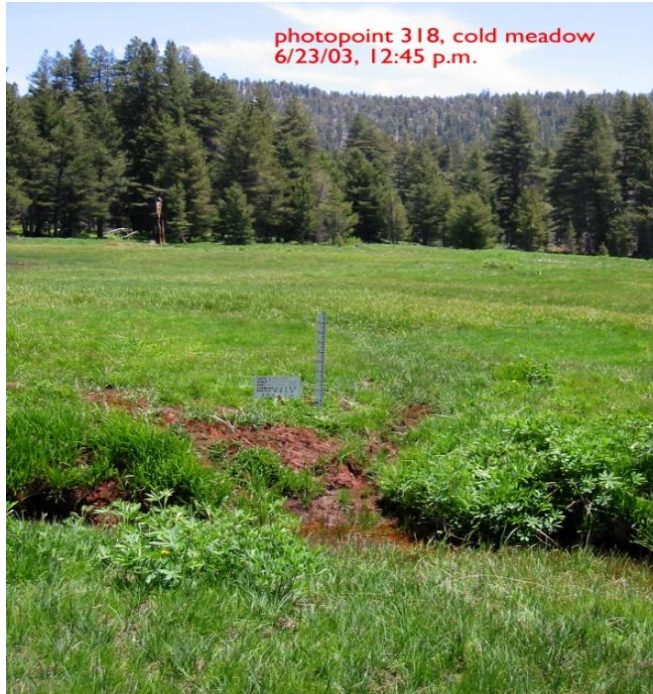
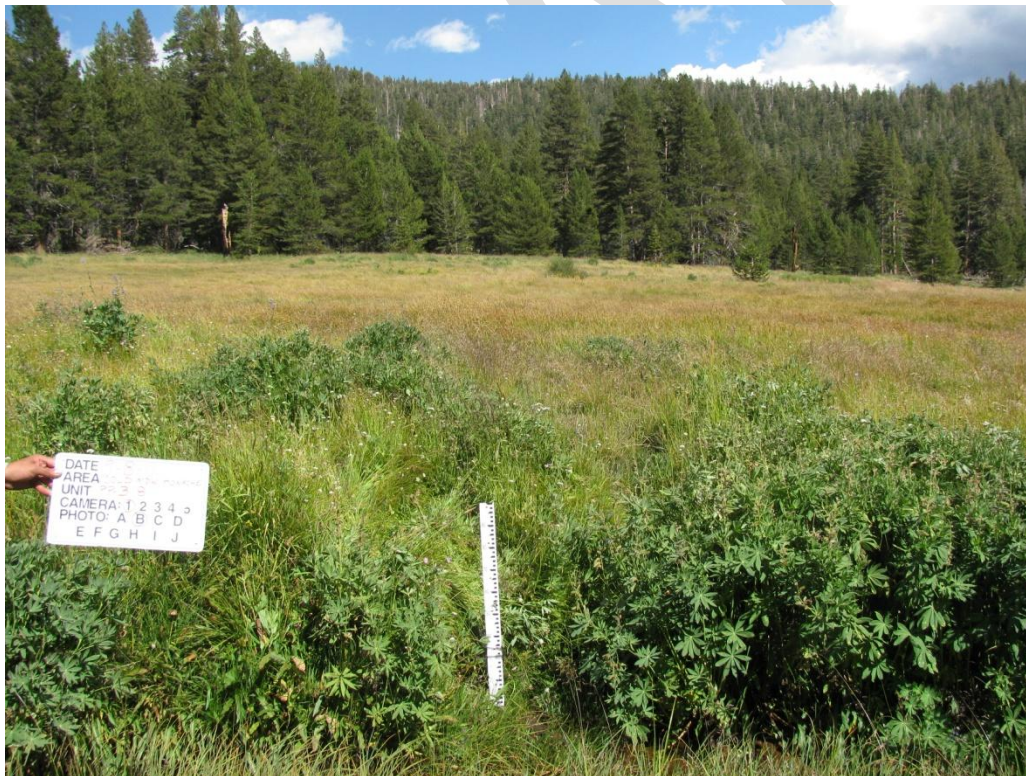
Above photo: Photo-point 318 (PP-318), Cold Meadow June 2003. Site is a degraded stream bank used as a cattle trail. **Below photo:** PP 318, Cold Meadow with photo re-taken September 2011. Site has fully recovered in terms of exposed soil and unstable stream bank with robust vegetation.

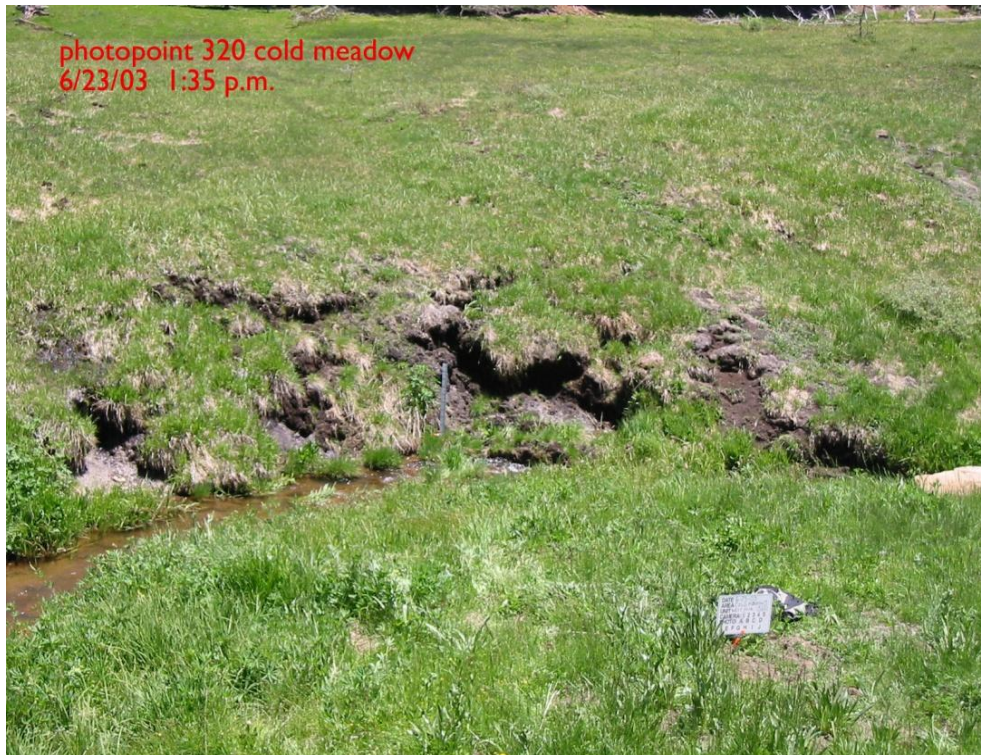
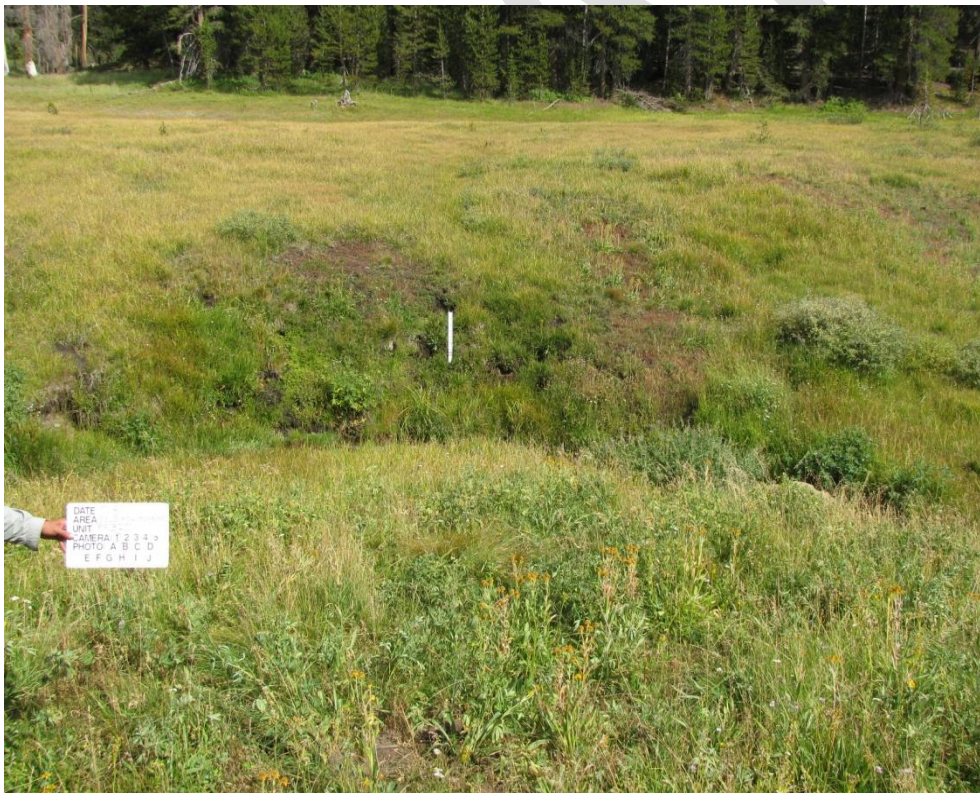
Above photo: Photo-point 320 (PP-320) Cold Meadow June 2003. Site is a degraded stream bank caused by cattle trailing and sapping seep flow. **Below photo:** PP-320 Cold Meadow with photo re-taken September 2011. Marked improvement on stream bank, Sloughing sod on banks has ceased and has filled in with vegetation and organic soil. Some areas of thin sod are present and vulnerable to trampling.

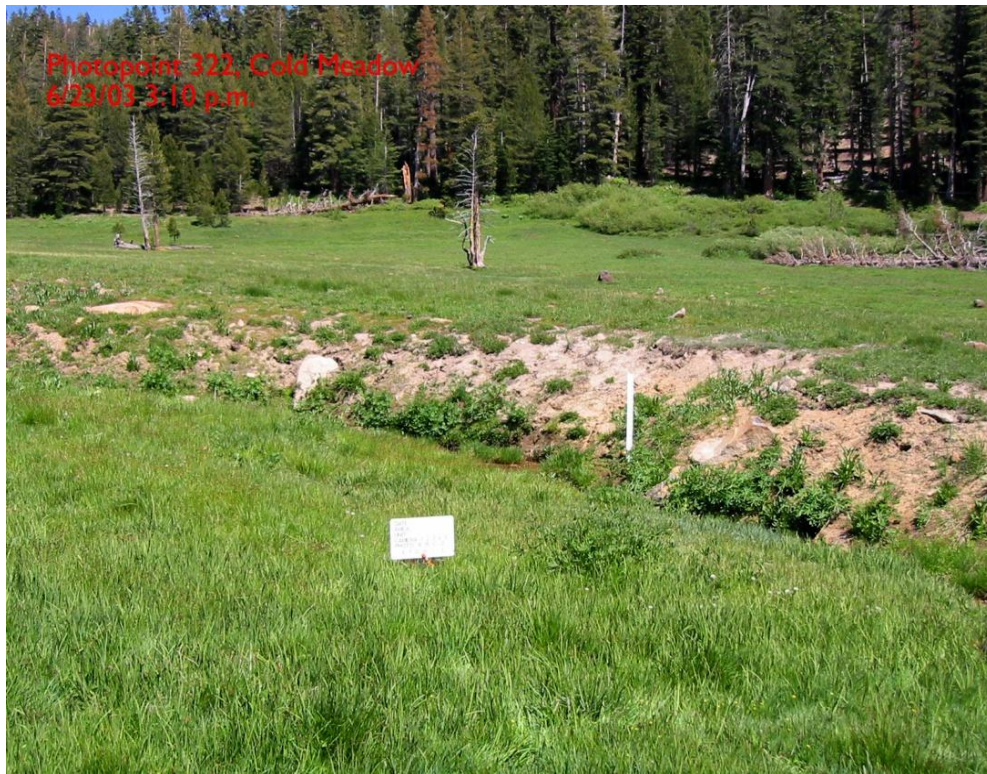
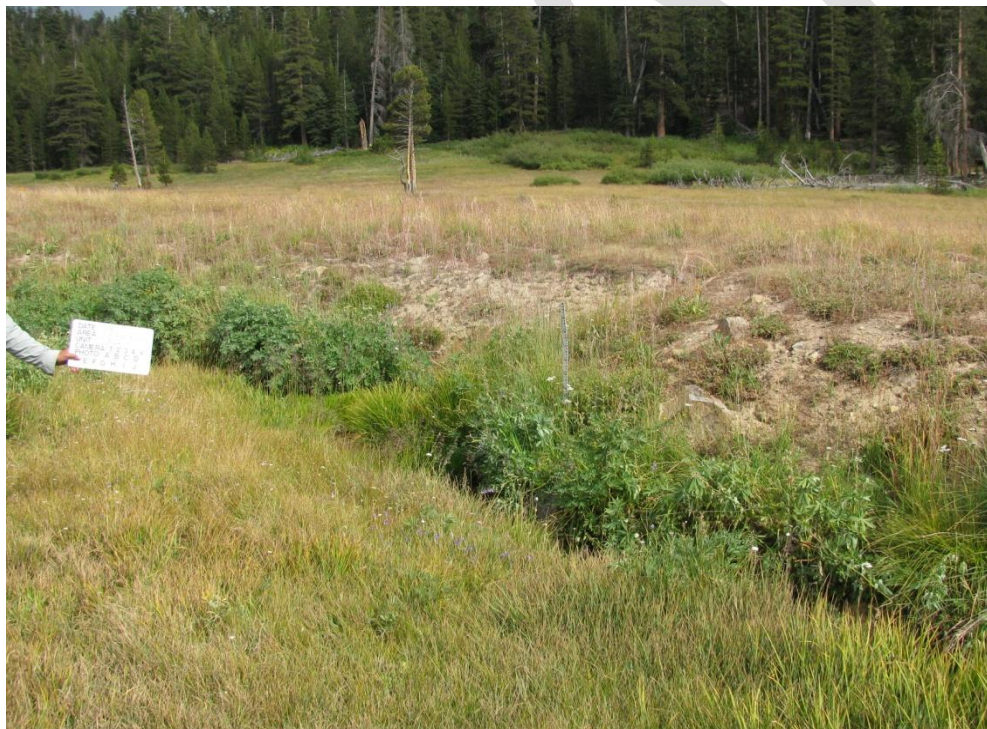
Above photo: Photo point 322 (PP-322) Cold Meadow June 2003. Site is a degraded stream bank with high amounts of bare soil on bank and missing vegetation. **Below photo:** PP-322 with photo re-taken September 2011. Bare soil areas have diminished in scale. Stream bank vegetation along channel has formed providing channel stability. Bare soil areas still exist on bank and are vulnerable. Vegetation cover on bank has increased approximately 60%.

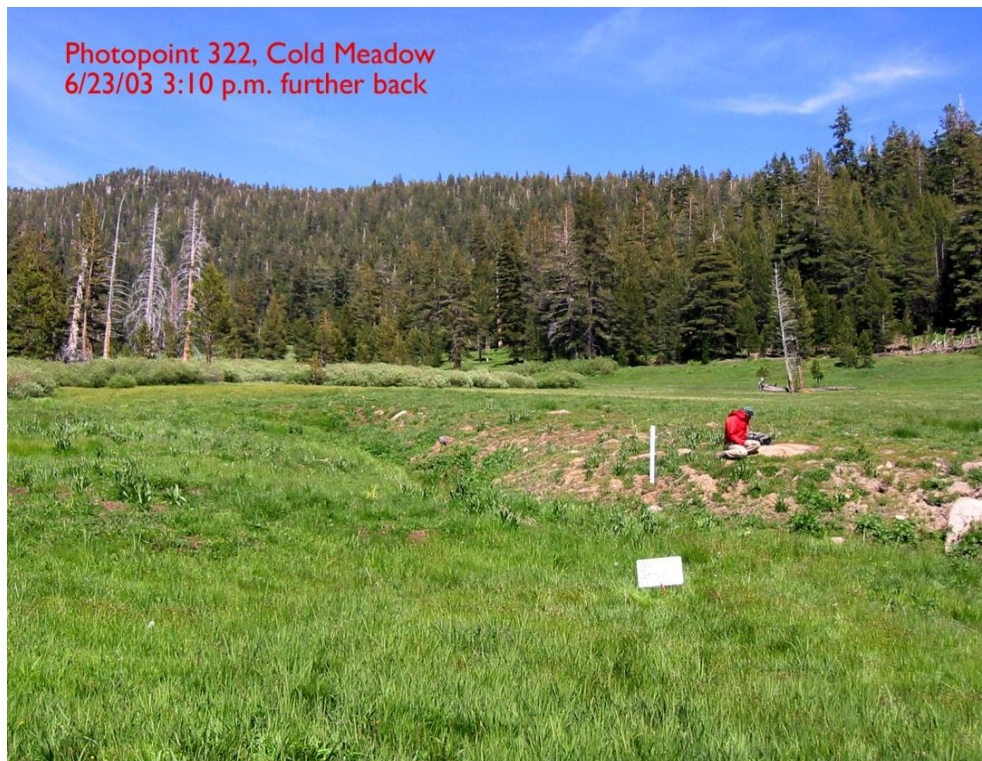
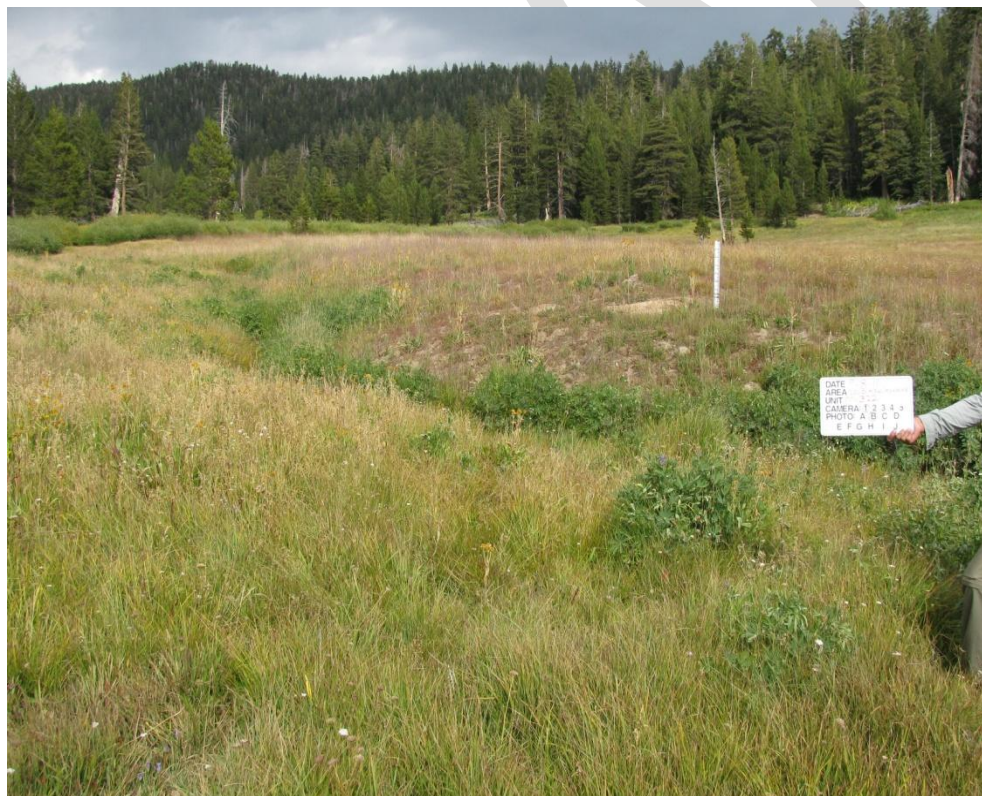
Above photo: PP-322 with a wider view of the site, Cold Meadow June 2003. Photo shows the large area of disturbance on the stream bank. **Below photo:** PP-322 Cold Meadow with same view re-taken September 2001. Wider view shows high increase of ground cover vegetation since 2003, with some instability existing.

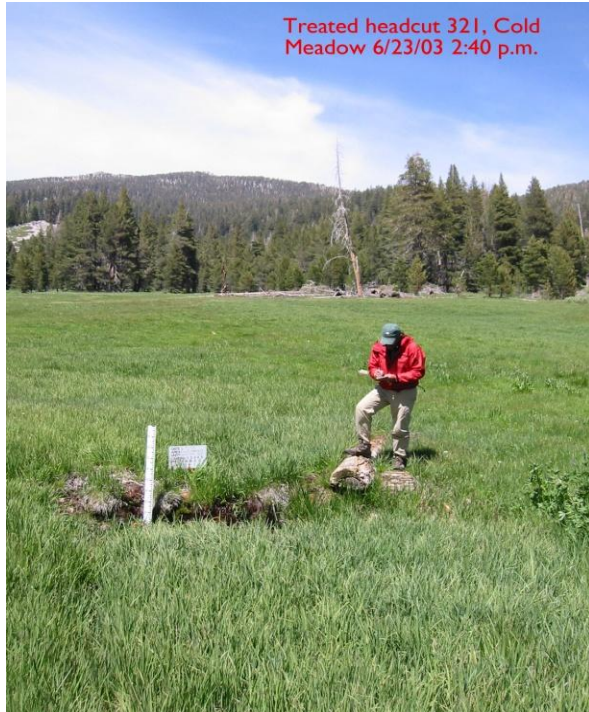
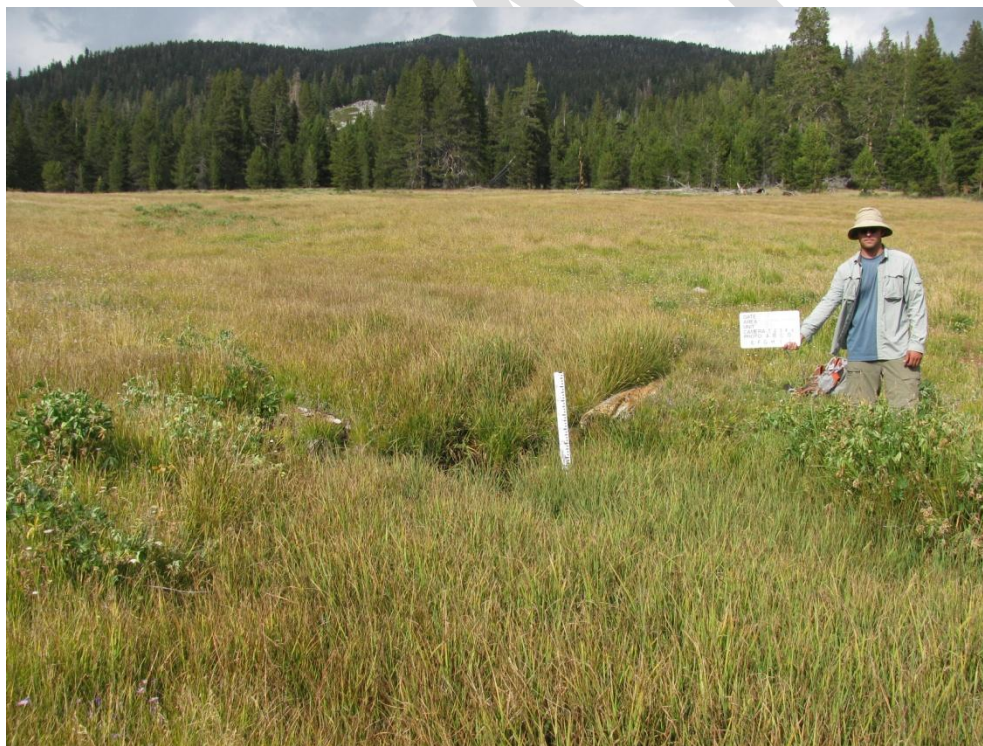
Above photo: Treated Head Cut 321 (THC-321), Cold Meadow with photo taken June 2003. Site is an old gully treatment (log check dam and spillway) built in 1950's. Only the spillway portion is left above the sod surface and treatment is meeting treatment prescription. **Below photo:** THC-321 Cold Meadow with photo re-taken September 2011. Meadow is continuing upward sod development and elevated water table. Flows are still moving across spillway. Eventually the structure will be completely sub-surface and water will not be guided by the structure and will find its natural path. This condition would then meet full treatment objective. No concerns or needs at this site.

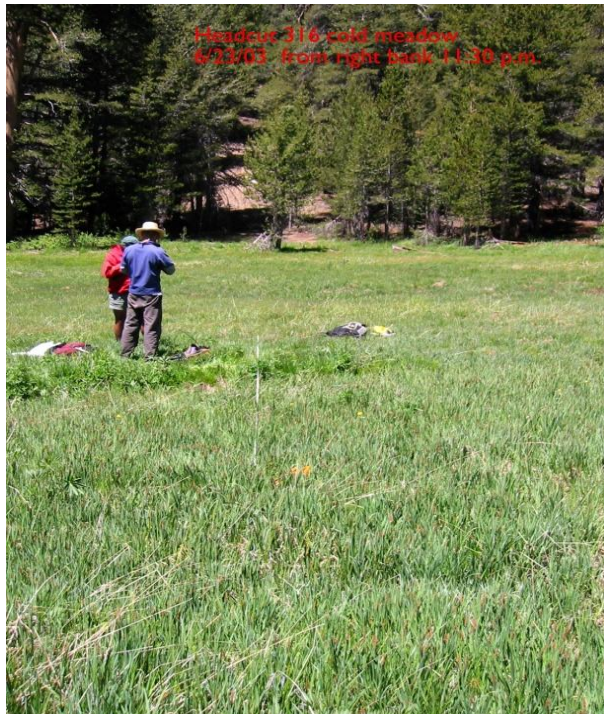
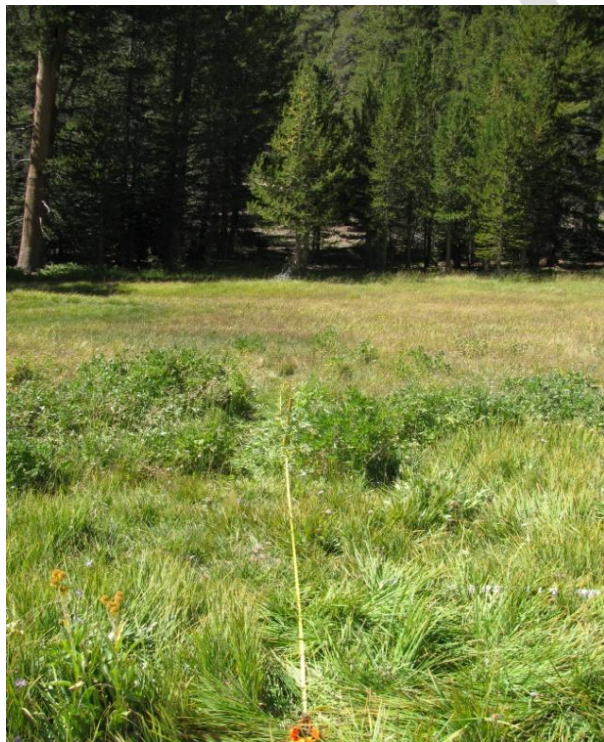
Above photo: Headcut 316 (HC-316) Cold Meadow, June 2003. Site is looking across transect at vegetation.

Below photo: HC-316 with same site photo re-taken September, 2011. Head cut has migrated 5.80 meters since 2003 and channel has not over-widened. HC is deep, erosion is occurring below rooting zone of sod, slope is moderately steep at this site increasing stream flow velocity and may be contributing to high migration rate. Site is suitable for HC treatment is a priority.

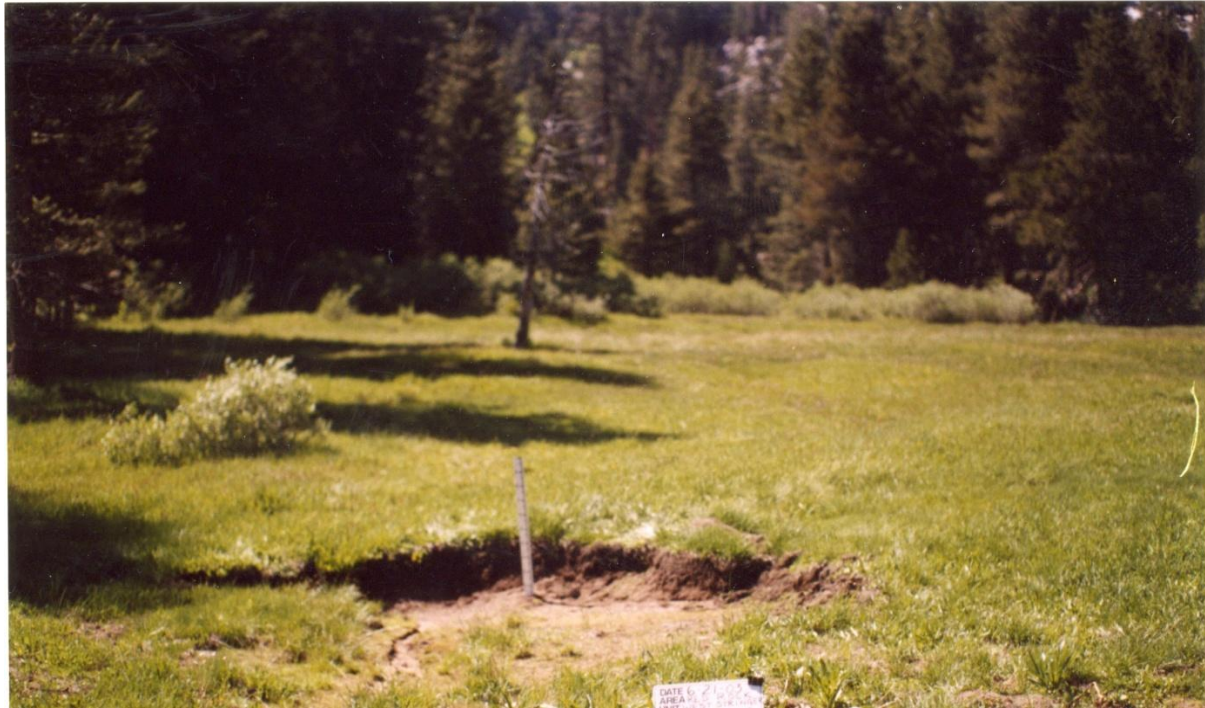
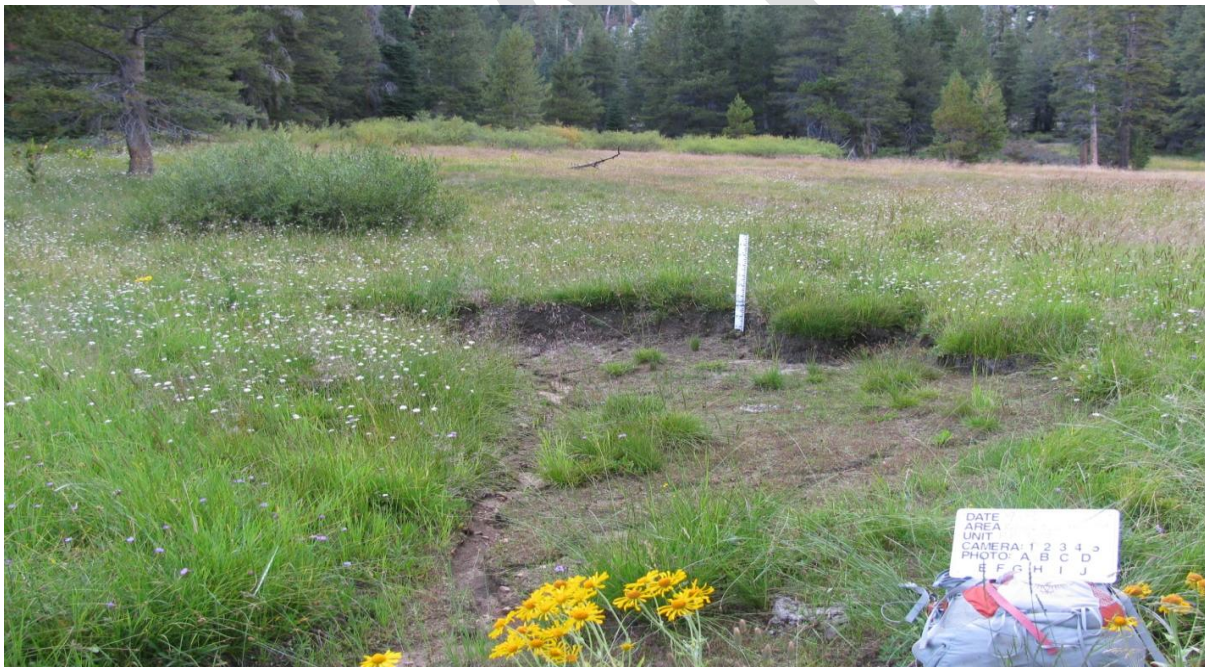
Above Photo: Photo-point 307-1a, NW portion of Redrocks Meadow, photo taken June 2003. Site is an eroded meadow slope where overland runoff gathers from above and pours over the cut. Soil is exposed with little vegetation showing on the bare area. **Below Photo:** Photo-point 307-1A, upper and west Redrock Meadows photo taken September 2011. Since 2003 monitoring, this site has shown an increase in stability, erosion of scalloped bare soil area has slowed and bare area extent has diminished. Some rilling is evident on bare area in photo indicating some vulnerability. Some slight erosion is still occurring along top of scallop, and robust vegetation is resisting erosion. Files of 2003 monitoring show initial photo.
